Preliminary Tree Survey

Everyone – A Division of Metricon

Site Address: 2 Tobruk St, Morwell, VIC

Trees Inspected: 02/08/2023

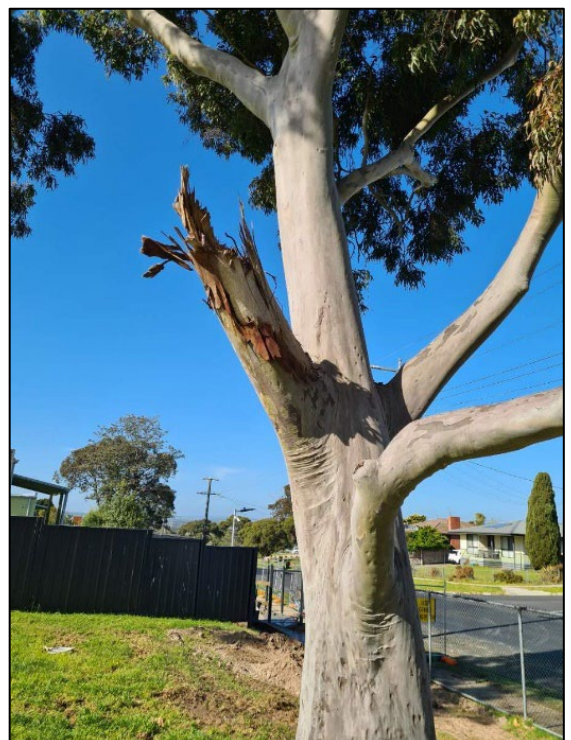
Figure 3: T1 major failed branch.

T1 (right) presented with a major failed branch on the North side. The failed branch is approximately 400mm in diameter and there is a significant broken stub remaining. The loss of this branch has left a large opening on the North side of the canopy and epicormic regrowth will need to be managed in the future. The broken stub should be pruned off.

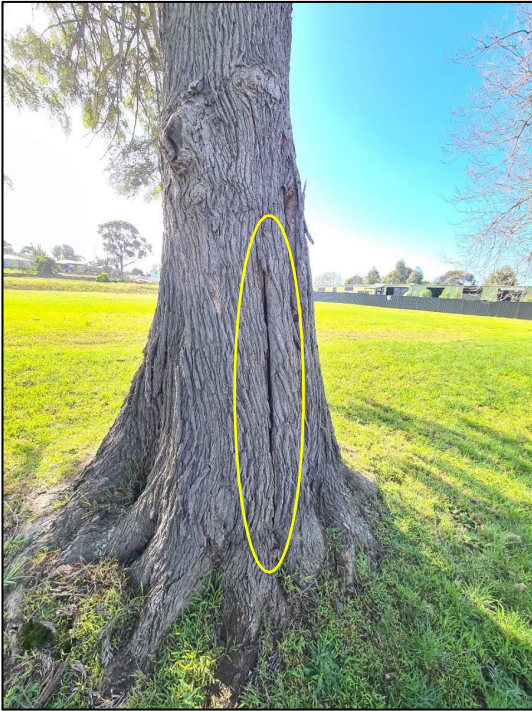
Figure 4: T3 Southern crack on trunk.

T3 presented with two very large longitudinal cracks in the main trunk near ground level. The cracks are on the Southern face between ground level and approximately 2 meters. The North side has a deep hollow cavity at the base that has decayed into the base of the tree. The base of this tree up to 2.5 meters was sounded with a mallet and returned a very hollow result in some areas. The targets within 1x tree height are the footpath, road, powerlines, power pole/transformer. The canopy presented in decline and dieback and deadwood was observed.

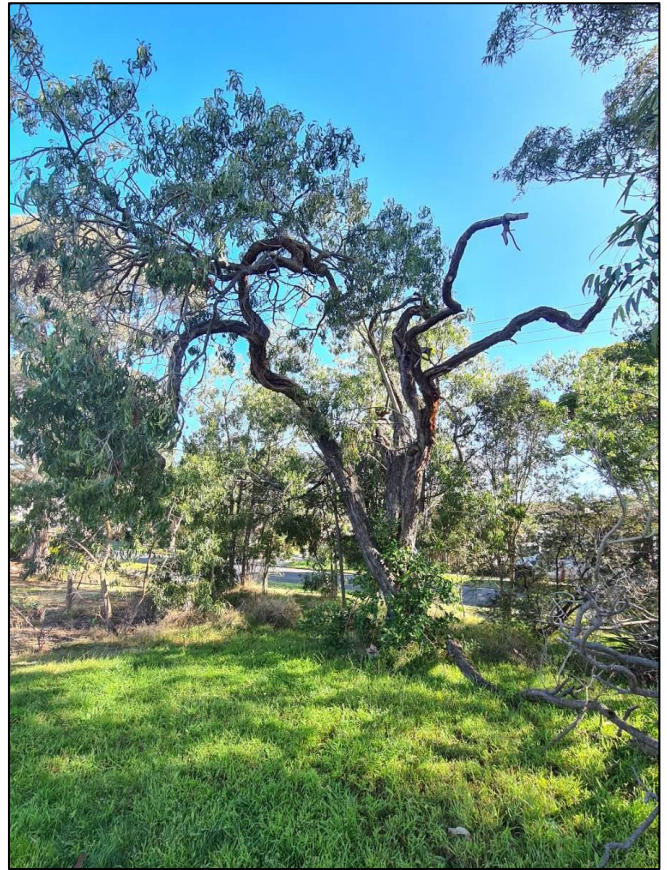
Figure 7: T14, failed and declining.

T14 presented very poorly. Its structure has failed and the tree is in severe decline. A large broken section is laying on the ground next to the tree. Several self-sown Blackwoods are now growing around T14 and should be removed as well. T14 has nil retention value and 0 years ULE. The site would benefit from the removal of T14.

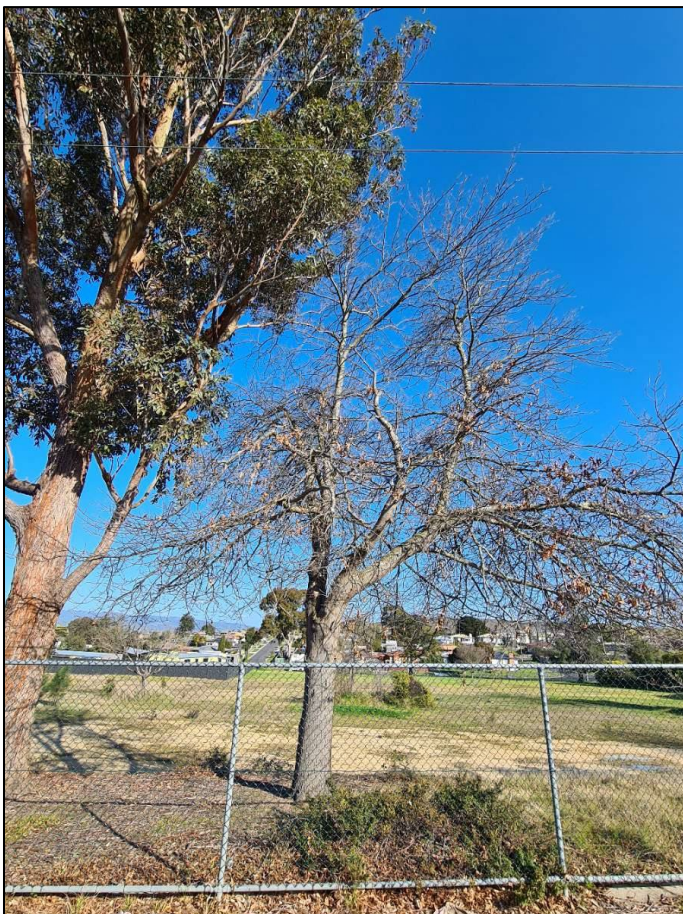
Figure 8: T21, very poor location under T22.

T21 (below) presented in poor condition due to its location directly under the canopy of a large native tree. T21 has been suppressed and the terminal leading stem has died back. There is a canopy bias to the South and West. Rain water or Slimeflux is exuding from a decayed branch stub and is staining the trunk. This has likely entered through the union or decayed wound above.

The potential mature size of this tree is approximately 15m x 15m. T21 is not suitable for retention, it has nil retention value and 0 years ULE. The removal of T21 would also benefit T22 to the East.

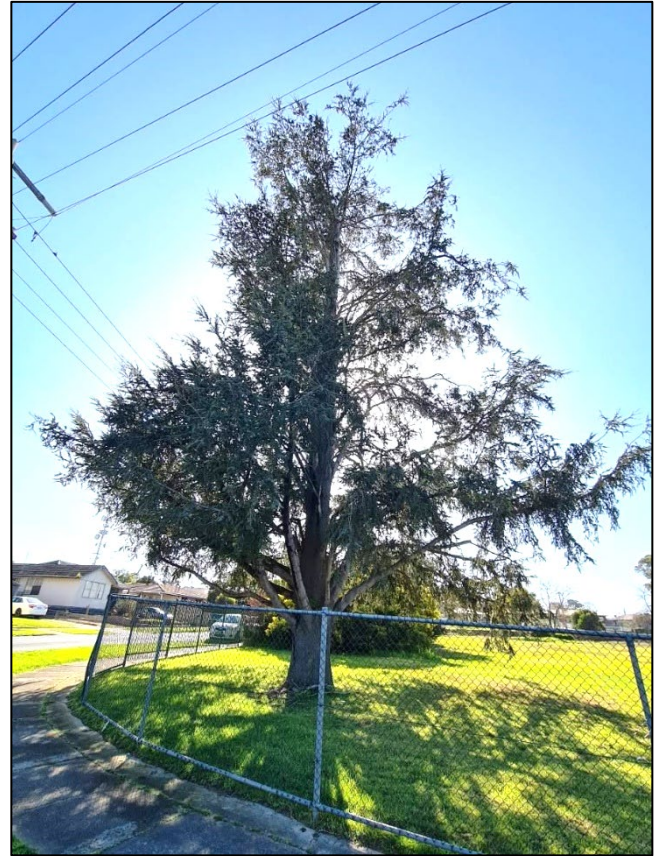
Figure 9: T5, Sparse canopy East side.

T5 presented with poor form and poor structure. This large exotic tree is located poorly and is in close proximity to overhead powerlines on the South and West side and a power pole on the corner of the site. The canopy is wider than the available space and has been heavily modified to fit the space. A canopy bias to the North and East was observed. The main stem has bifurcated at approximately 5m from ground level. This bifurcation is very acute and potentially has included bark within the union. Pieces of internal deadwood up to approximately 75-100mm were observed. Several broken branches were visible from ground level. A large hanging dead branch is caught in the canopy on the North side. The canopy is sparse and open on the North and East side. T5 has low retention value due to its poor location next to infrastructure, poor structure and sparse canopy. The ULE is 5>10 years.

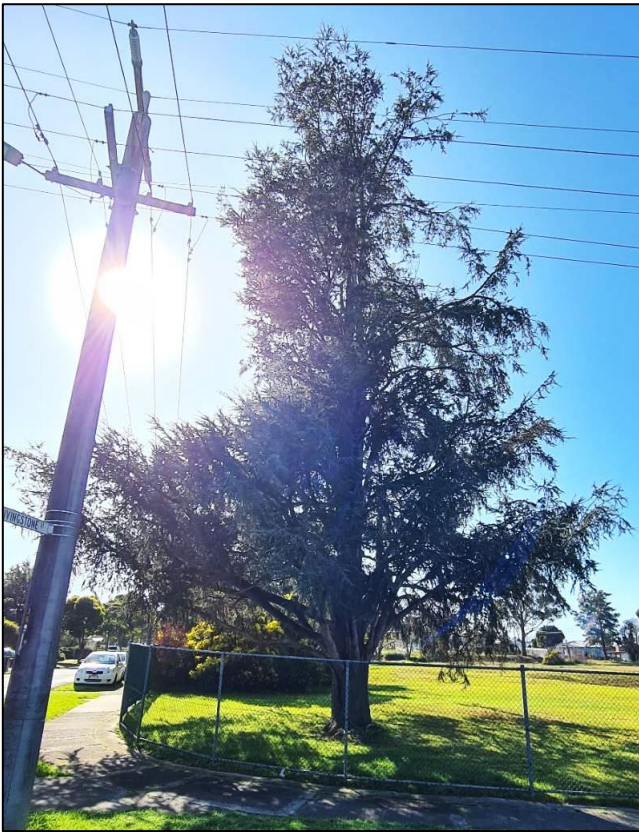
Tree #5

Tree #	Botanical Name	Common Name	Age	Origin	D.B.H (cm)	Calculated D.B.H (cm)	D.A.R.B (cm)	Height (m)	Width (m)	Health	Form	Structure	Retention Value	U.L.E	Comments
5	<i>Cedrus libani</i>	Lebanese Cedar	Over Mature	Exotic	98	98	104	16	17	Fair	Poor	Poor	Low	5 > 10 years	Very close to powerlines on south and west side, heavily modified to clear away from lines, footpath and road in target are, multiple broken branches hung up in canopy, sparse canopy, bifurcated from 5m with very acute main union, large branches growing vertically through canopy are crossing multiple branches, lopped branch stubs, poor location for size of tree, likely to be senescing, east side is very sparse,
6	<i>Acacia retinodes</i>	Silver Wattle	Mature	Native	15	15	17	4	6	Good	Fair	Poor	Nil	5 > 10 years	Multistemed large shrub form,
7	<i>Liquidambar styraciflua</i>	Liquidambar	Mature	Exotic	40*30	50	60	7	7	Poor	Very Poor	Failed	Nil	0 years	Multiple broken branches and dieback of main leader, poor main union, fungal brackets at base of tree, delaminating bark, dead cambium,

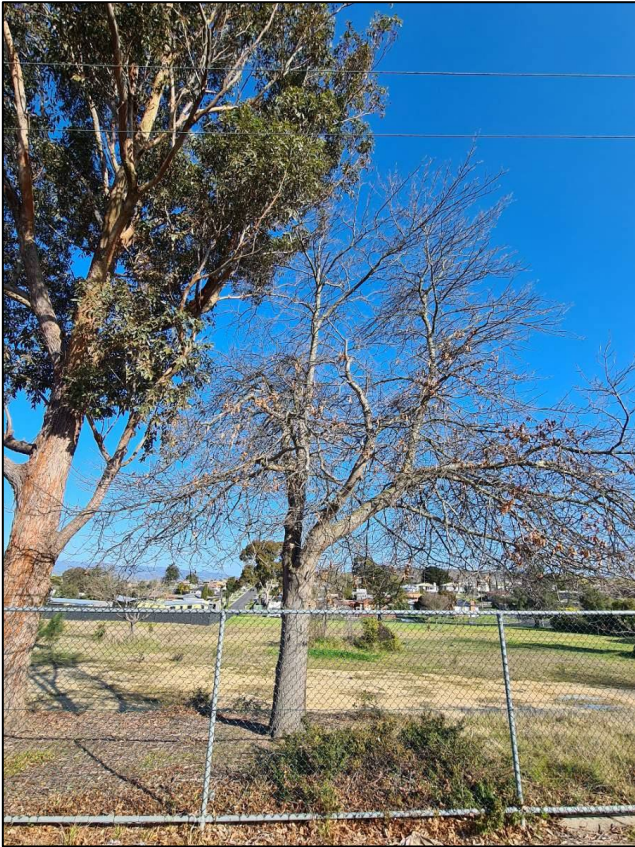
Tree #21

21	<i>Quercus palustris</i>	Pin Oak	Semi-Mature	Exotic	49	49	59	9	7	Fair	Very Poor	Poor	Nil	0 years	Lopped away from powerlines north side, growing under canopy of larger tree, lead has died back, codominant from 3m with poor union, water/Slimeflux leaking from decayed branch stub likely from codominant union above, very poor location for current and mature size, very

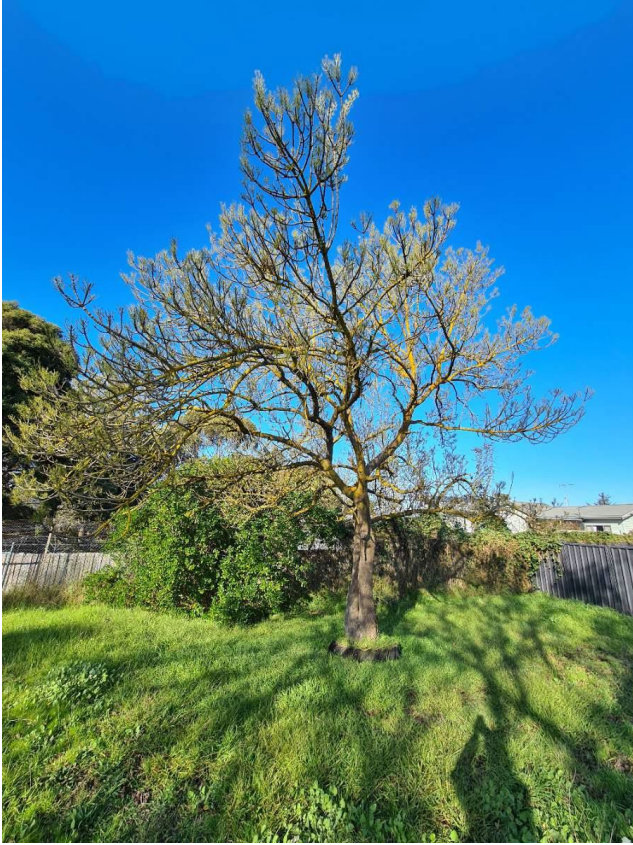
Tree #29

29	<i>Fraxinus angustifolia</i>	Narrow Leaved Ash	Mature	Weed Species	23*23	33	53	8	8	Fair	Fair	Poor	Nil	0 years	Weed, bifurcated, large rubber tire around base of tree,
