# Latrobe Planning Scheme Amendment C87, Qualitative Risk Assessment

Submitted to: Maddocks 140 William Street Melbourne Vic 3000

1539765-003-R-Rev0

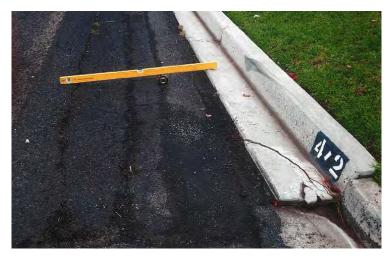
Source: LaTrobe City Council

Council also provided observations that included cracking of concrete aprons within and adjacent to two properties located in Wallace Street. Stormwater outlets from two other properties have also had to be realigned to allow drainage to occur.

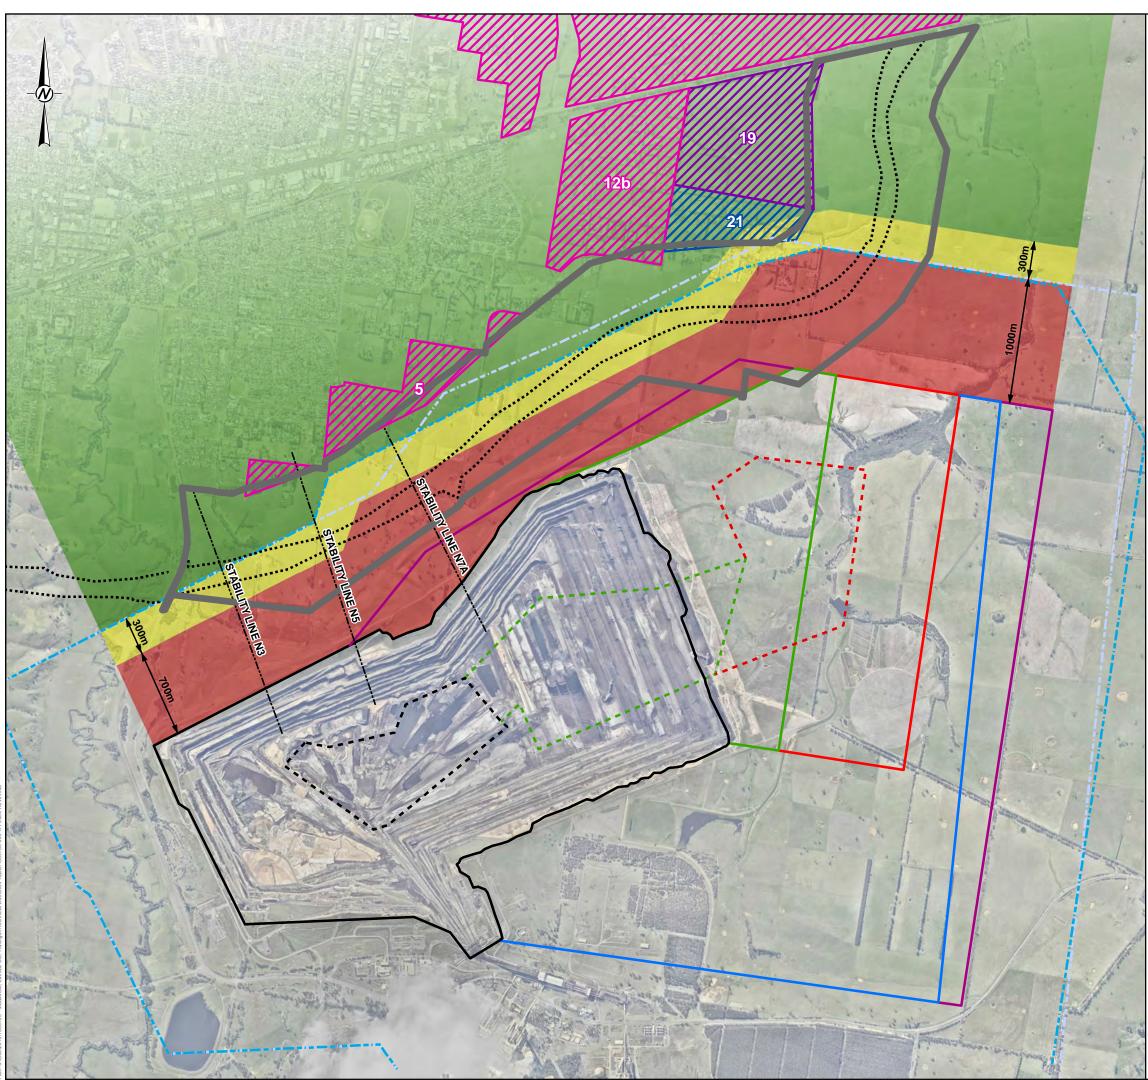
The area within Zone 1 is highlighted red on Figure B3, Appendix B. This area has an assessed current level of risk to development that is high to very high and development in this area is therefore unlikely. The area defined as Zone 1 generally extends 700 m behind the current and proposed crest of the Loy Yang Mine pit, but to the east has been extended to 1.0 km, as discussed below. This Zone is exposed to ground movement both due to stress relief and aquifer depressurisation, and closer to the mine crest (within this Zone) to the potential hazard of mine related instability.
