Final Study Report

Latrobe River Flood Study

Prepared for West Gippsland CMA

March 2015

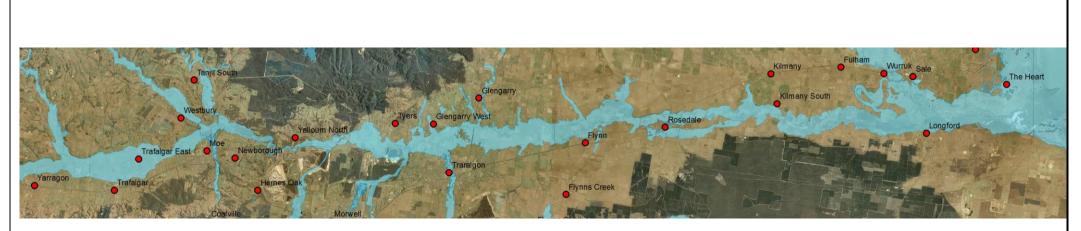
Our current understanding of the extent of a 1-in-100 year flood event is shown in blue on the above map. For greater detail in specific areas, please contact the WGCMA. Keep in mind that this study only relates to flooding on the Moe and Latrobe Rivers.

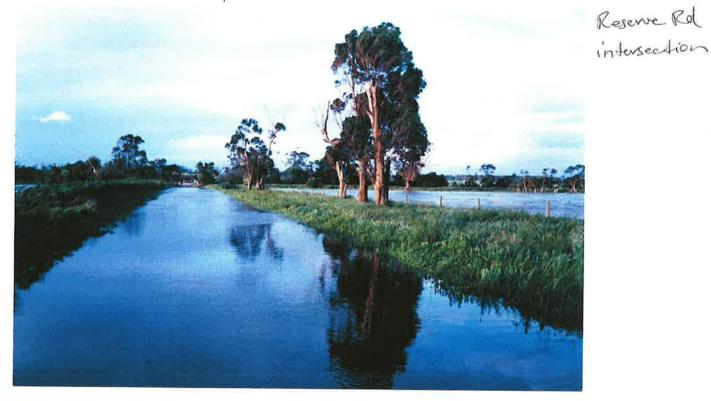
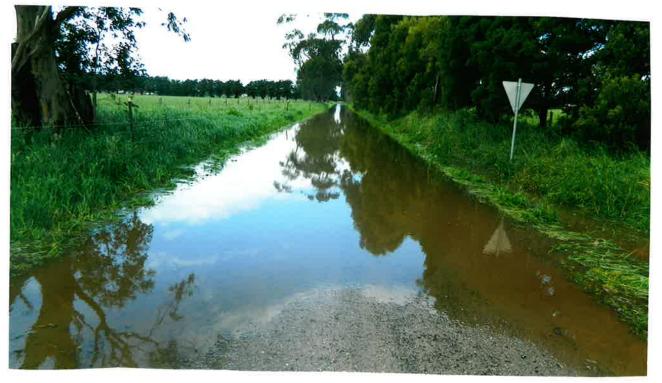
Factory Road, Youvrason looking north to Moe River from

Factory Road Reserve Road, Yarrason-intersection 2013

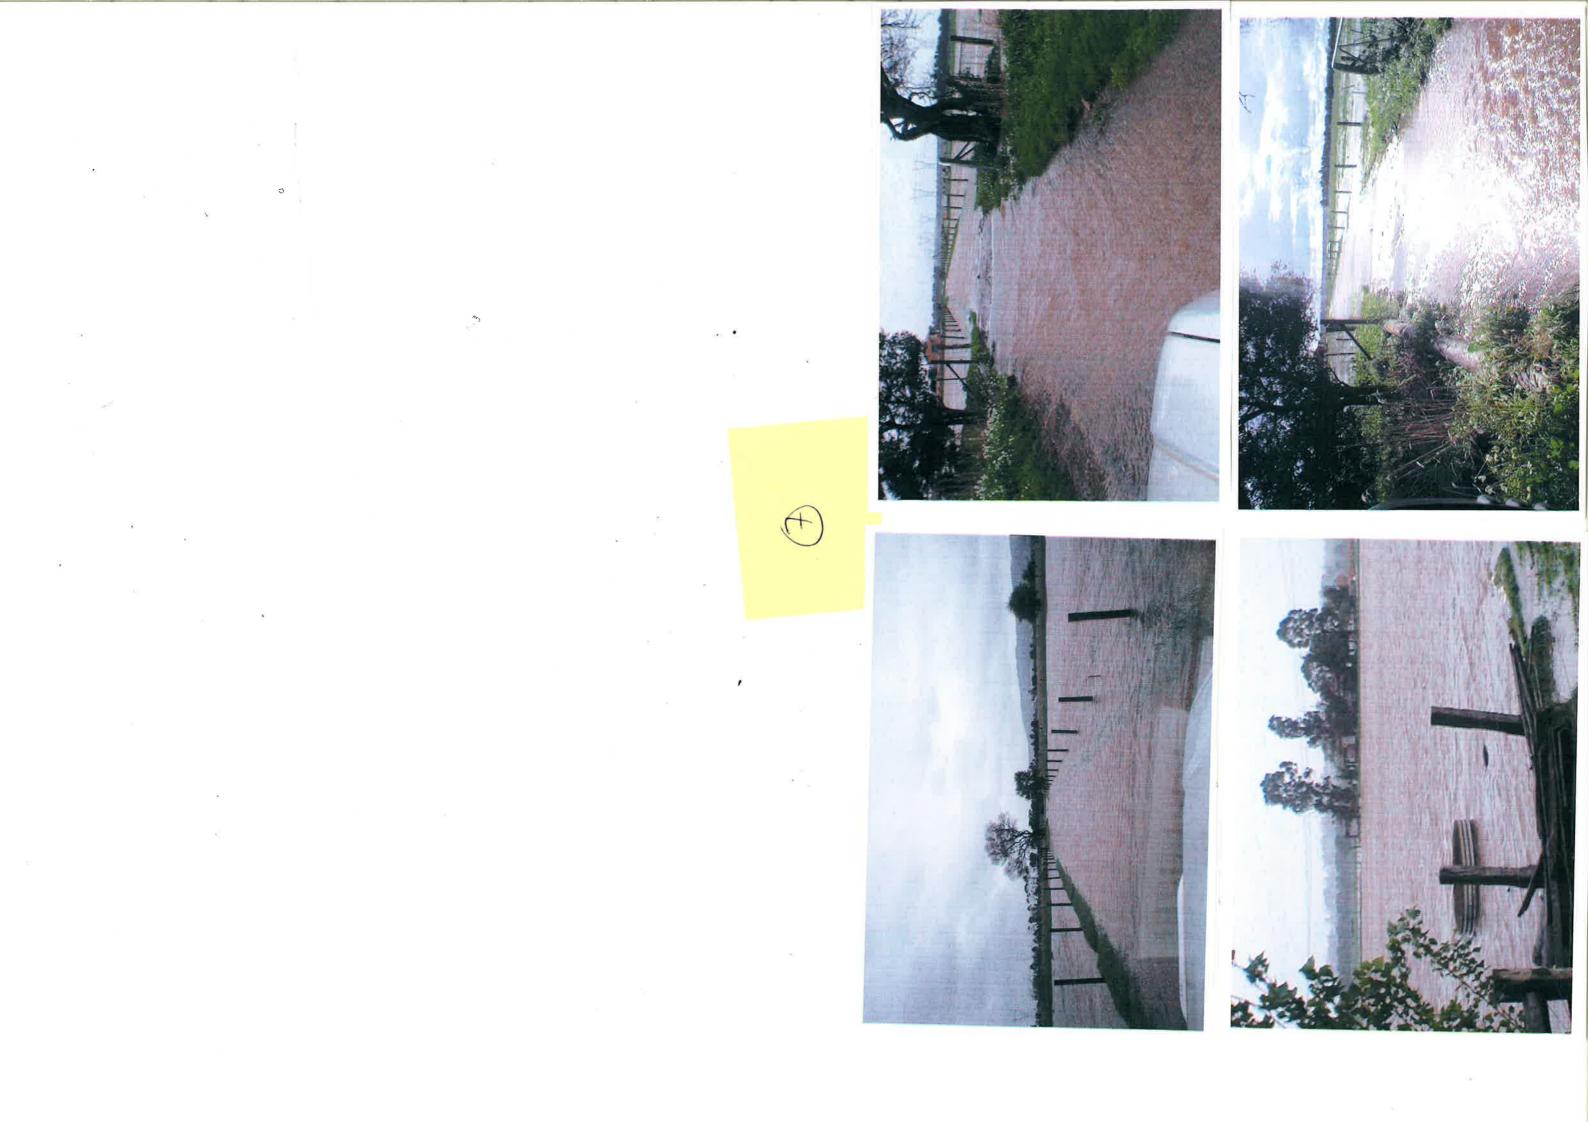
Have seen Flood water comerned OUT THE DRIVE ABOUT à POOT and a Half High WHEN WORER Flowed OVER THE MOE RIVER. BUNN of SWER RIVER. on Eight mile ad Looking FRONT OF DRIVE Way, UP THE BRIVEWAY. Leokina N/West Towards House DRIVEING OUT of DRIVE TO FROM Neighbours DRIVE Way Eight will Reed. 2009.

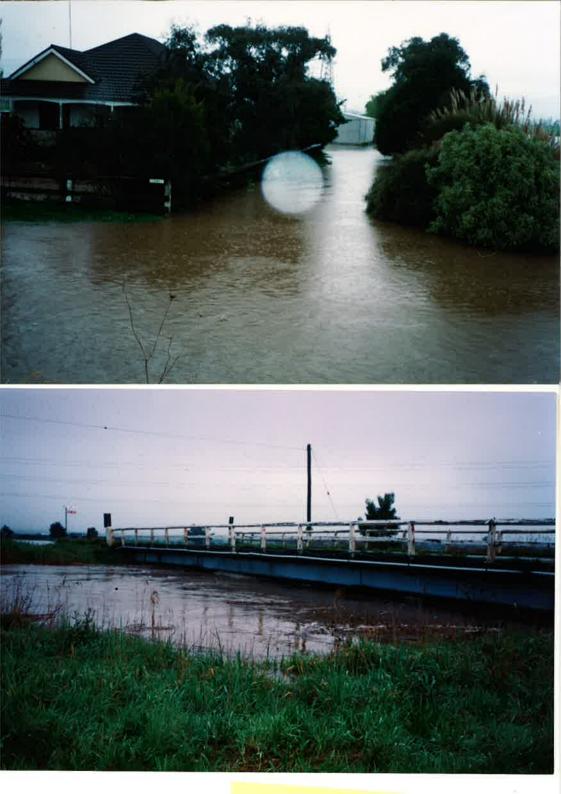
8 MICE ROAD FLOODED WHICH FLOWED EAST OVER AND AKINOSS JAMES FARM

168 South CANAL RO TRAF-WASTER FROM SUNNY CK OLD SEVEN MILE BRIDGE CNOVIE-TRAFE ROTAD WILLOW OK RWER FLOWING

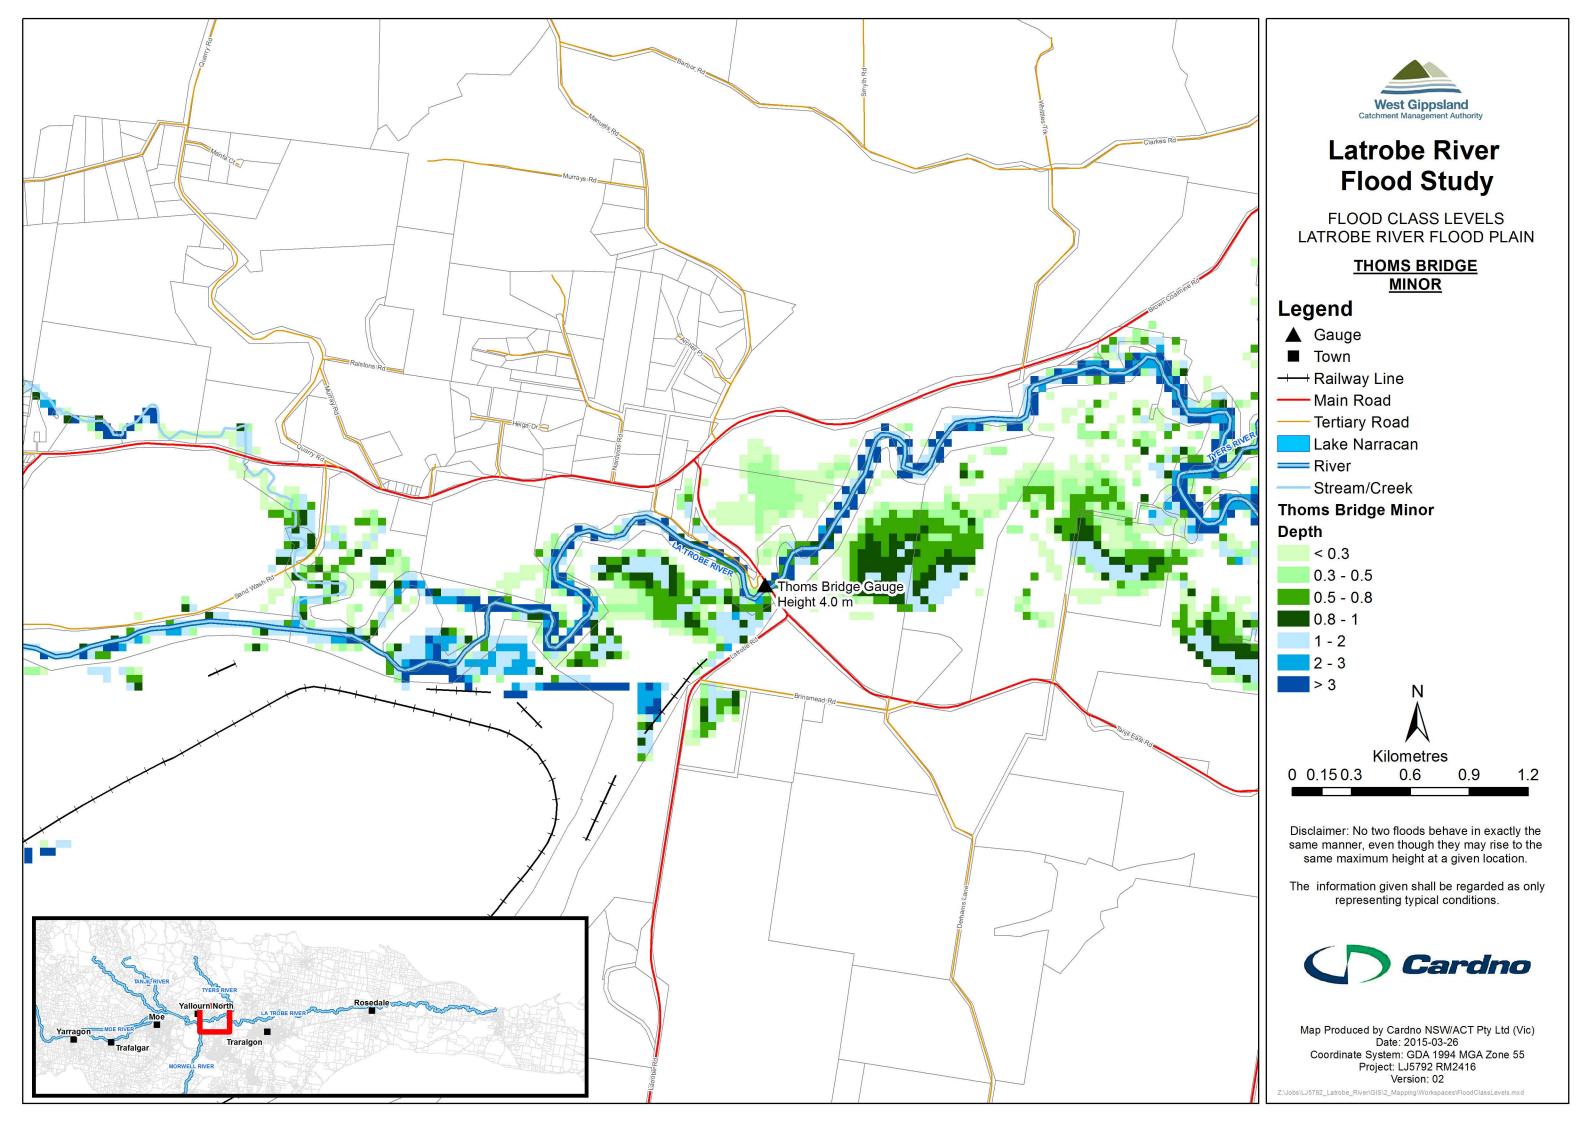
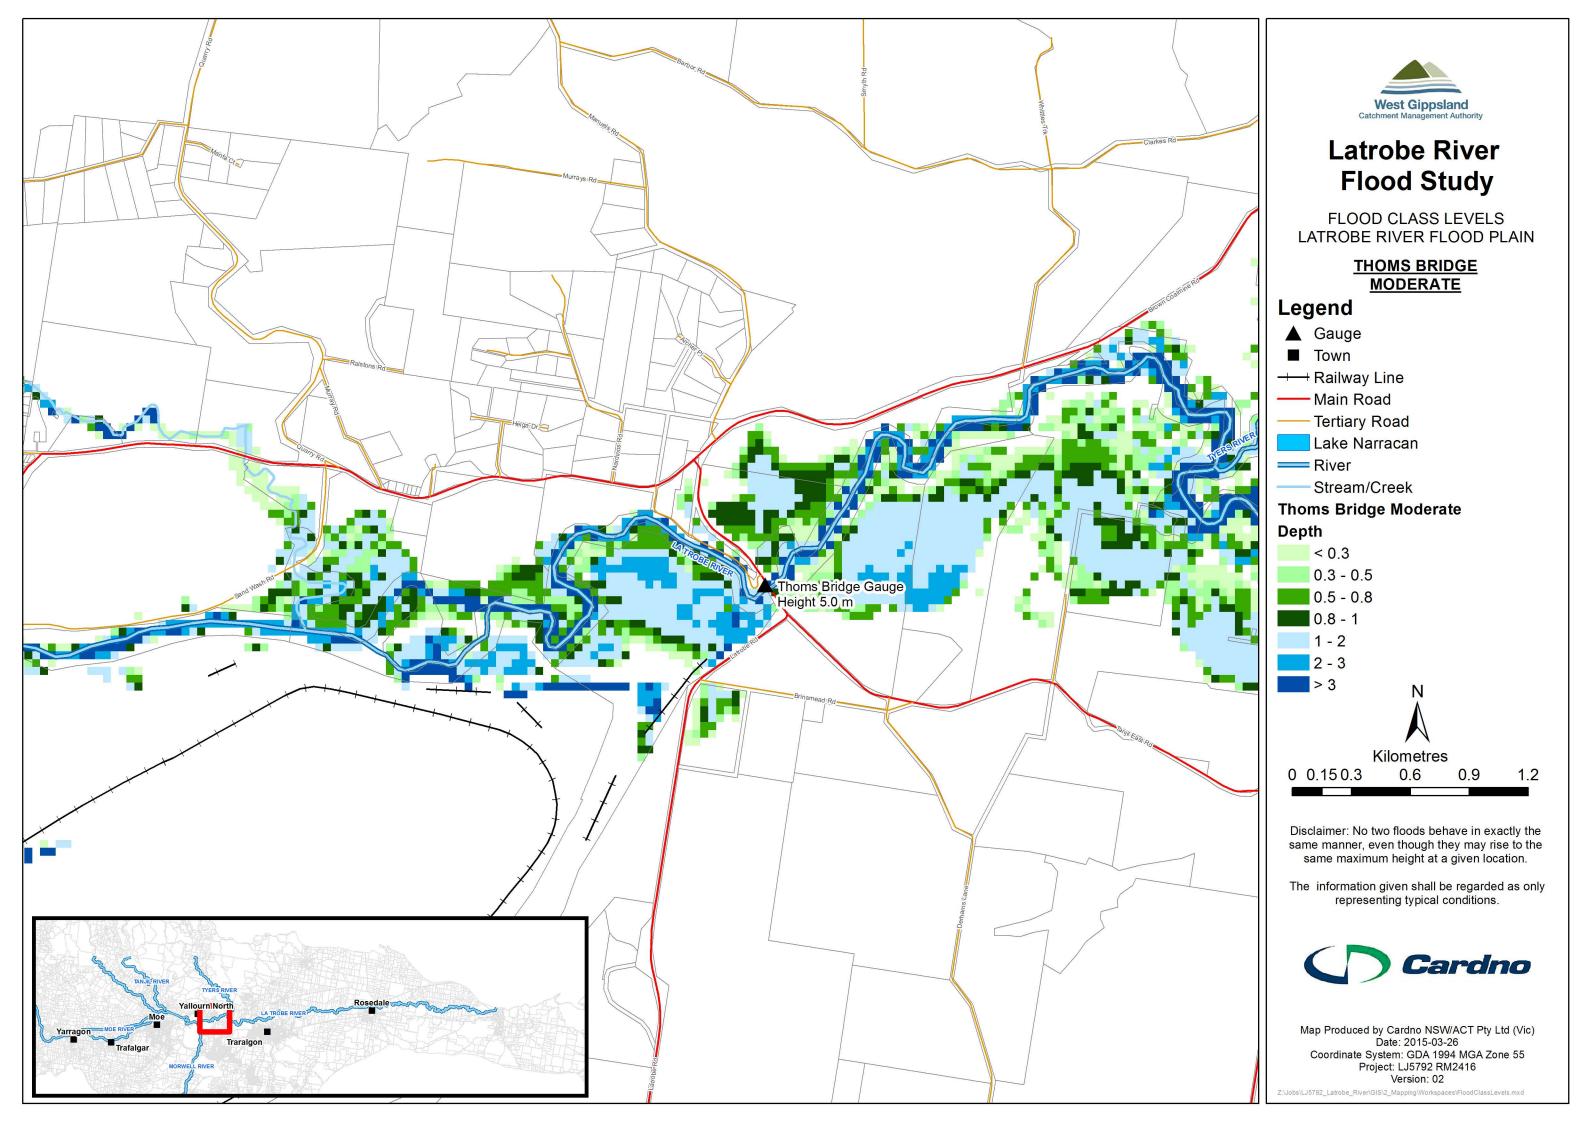
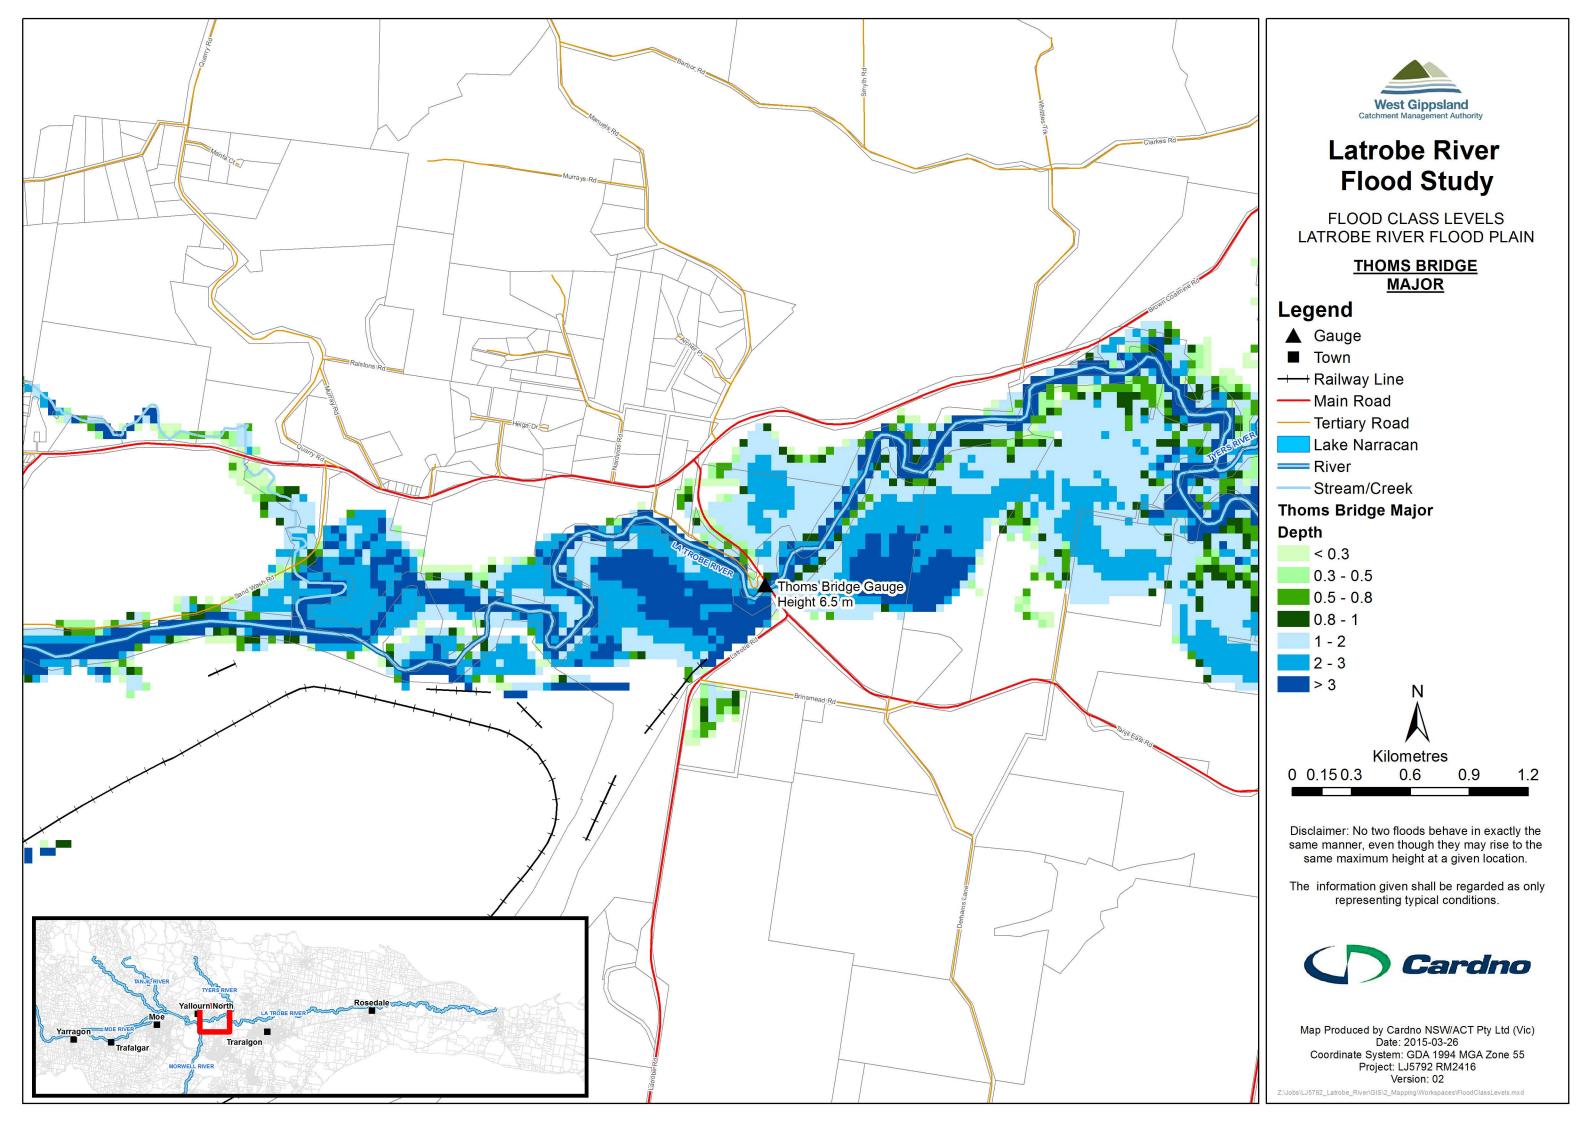
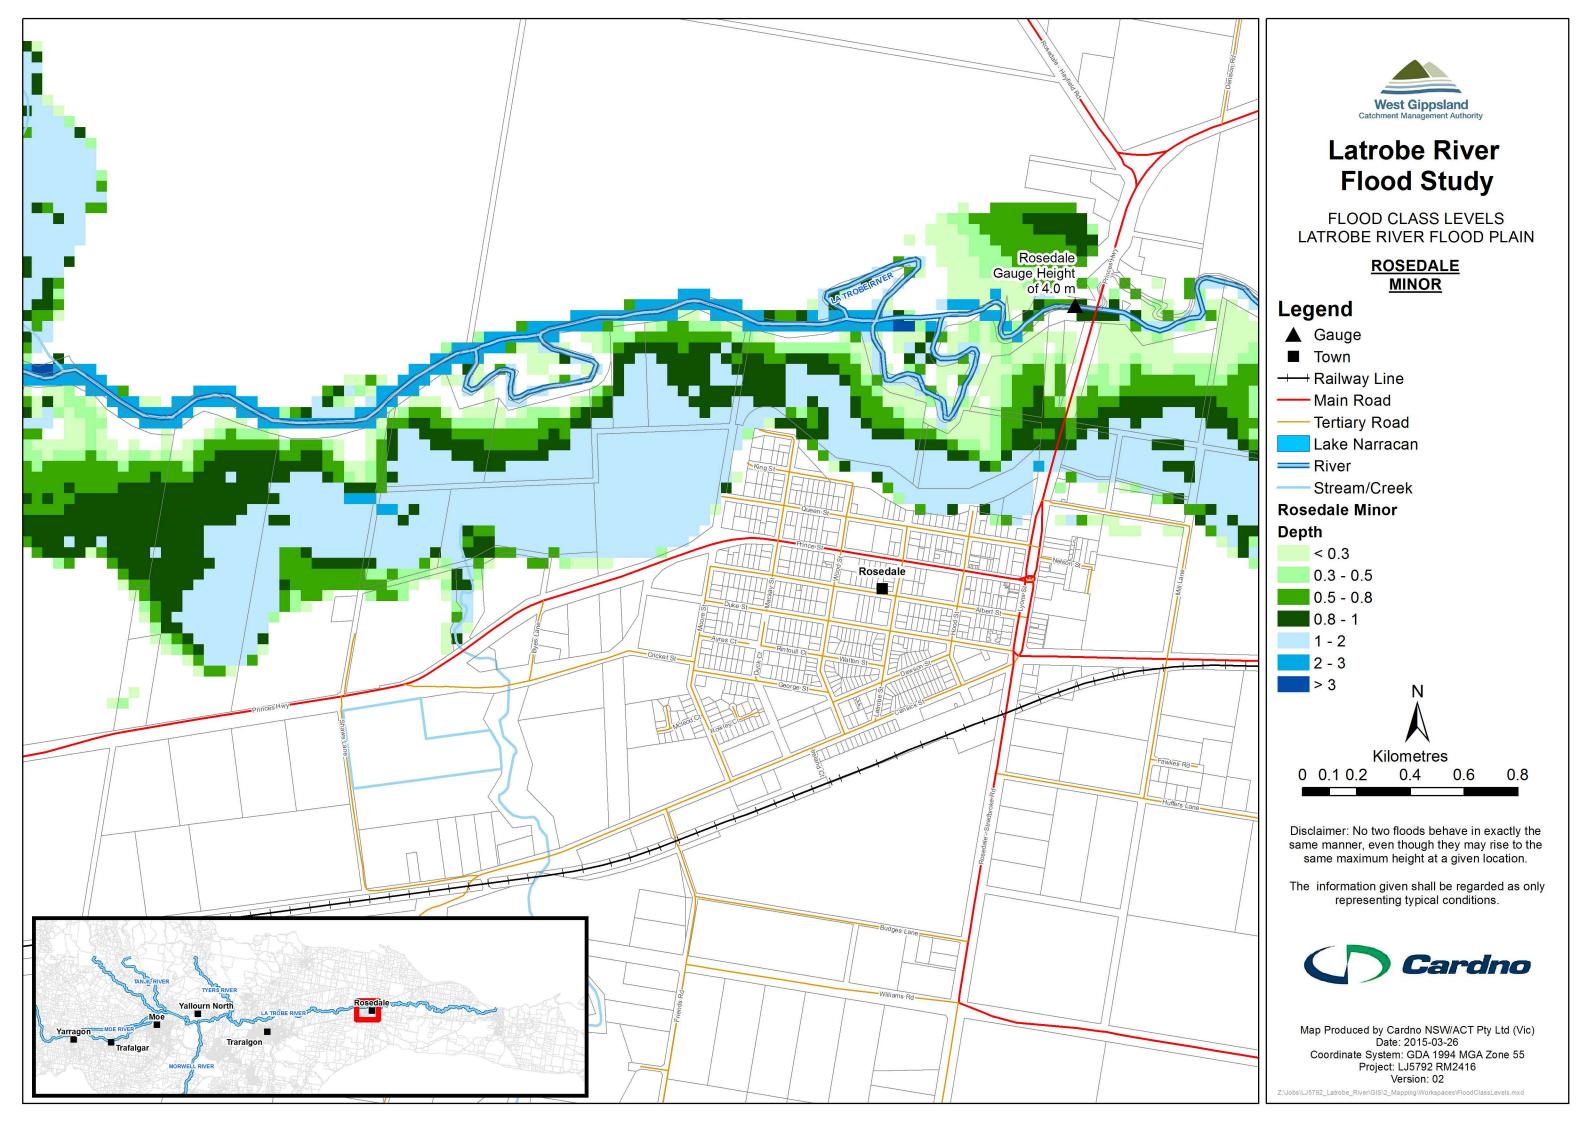
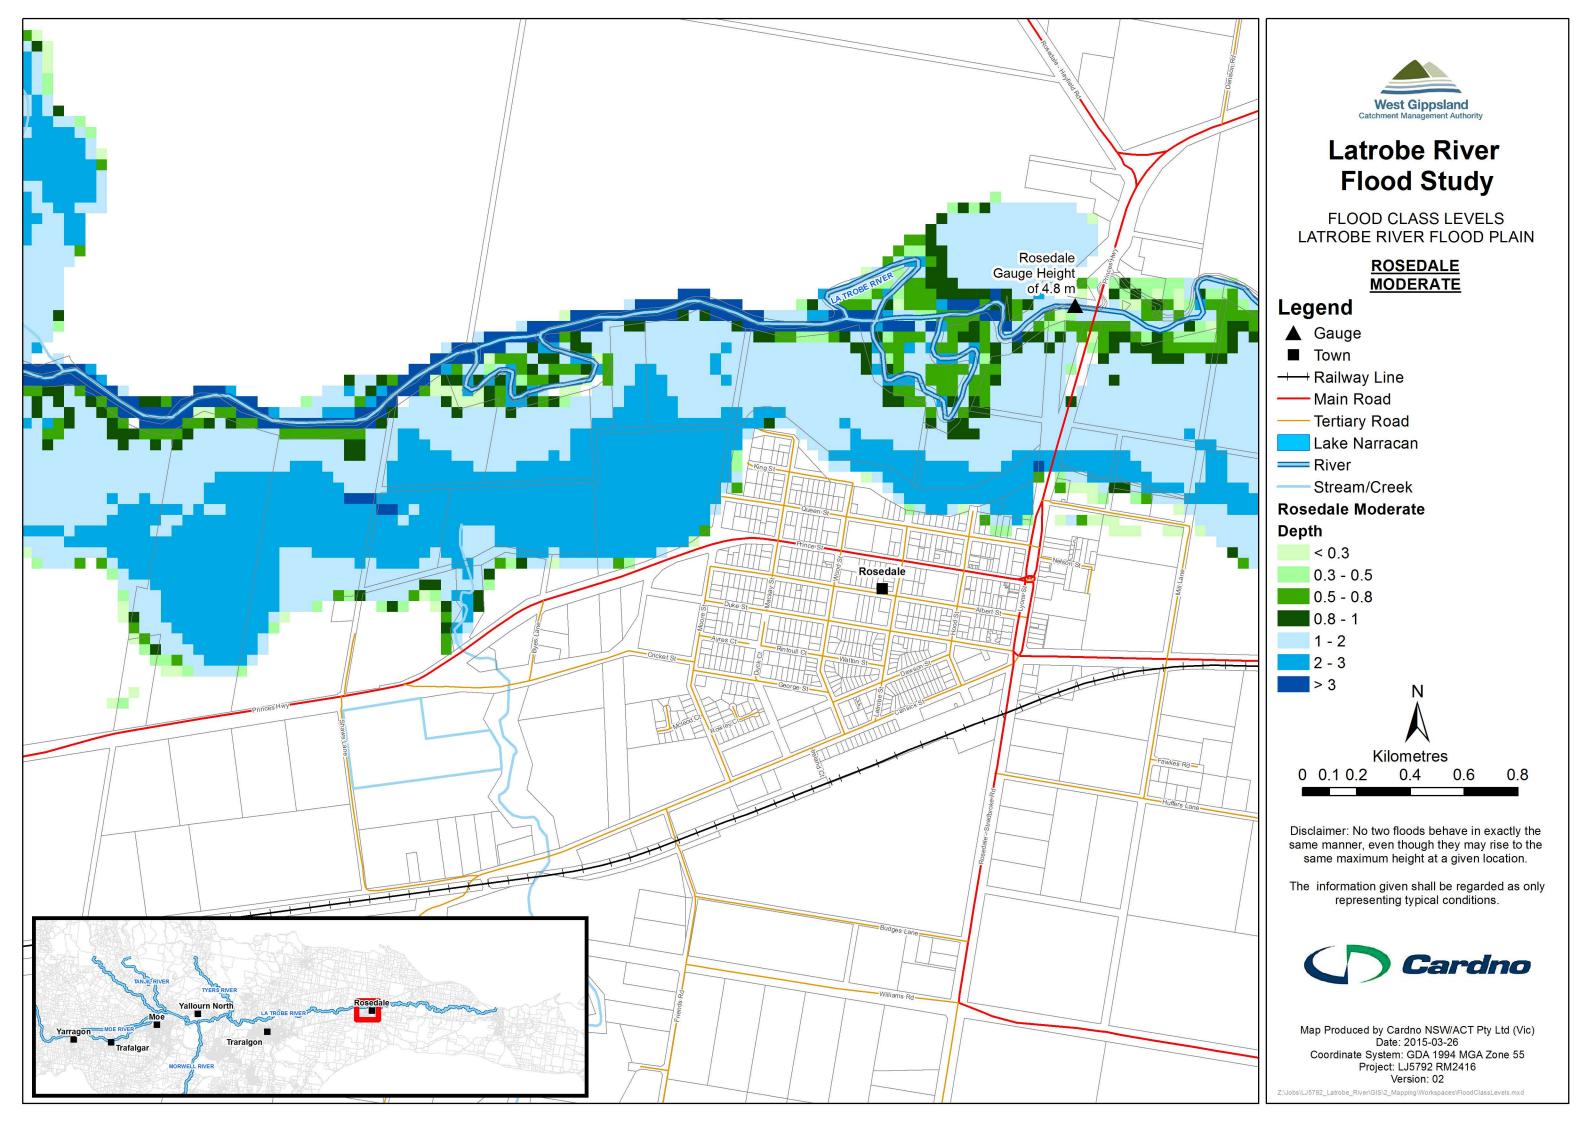
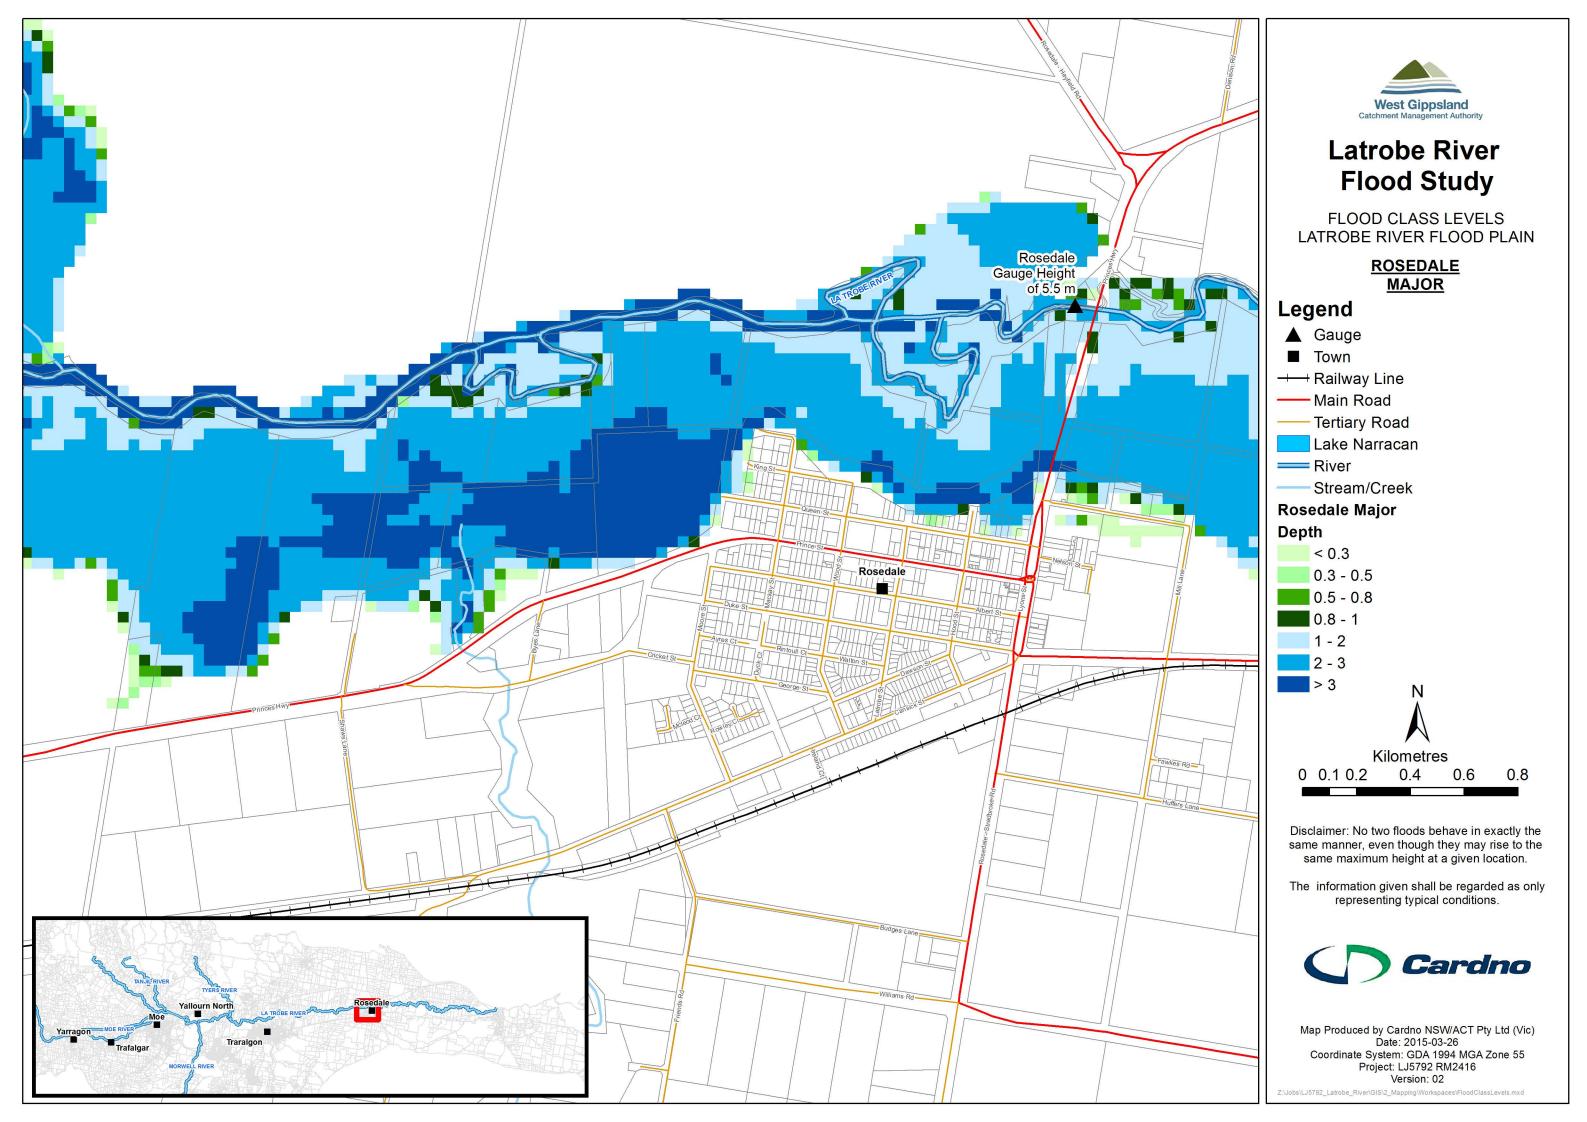
APPENDIX C FLOOD CLASS LEVEL MAPS -THOMS BRIDGE AND ROSEDALE

Analysis has been undertaken to determine the inundation associated with the Bureau of Meteorology's flood class levels at the Thoms Bridge gauge – these maps can be found in Appendix C.

Analysis has been undertaken to determine the inundation associated with the Bureau of Meteorology's flood class levels at the Rosedale gauge – these maps can be found in Appendix C.
