Preliminary Tree Survey

Everyone – A Division of Metricon

Site Address: 2 Tobruk St, Morwell, VIC

Trees Inspected: 02/08/2023

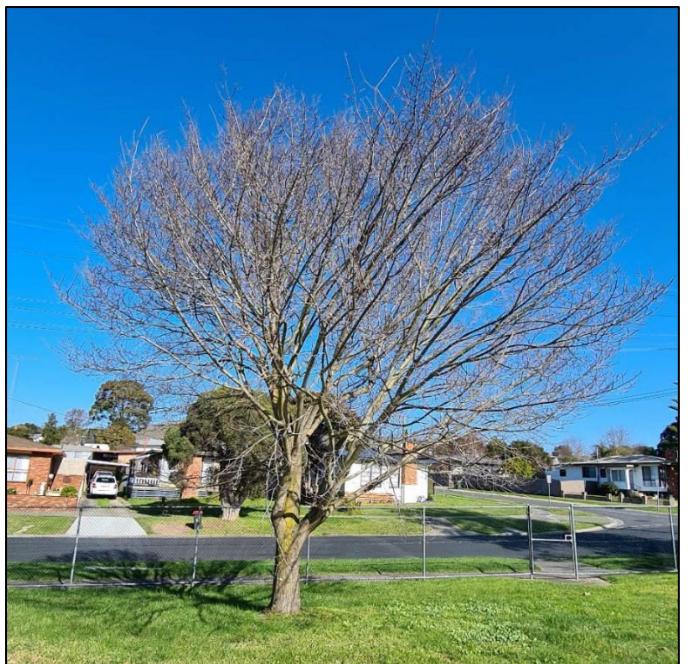
Tree #4

4	<i>Ulmus glabra</i>	Golden Elm	Semi-Mature	Exotic	38	38	45	7	8	Fair	Good	Fair	Low	5 > 15 years	Codominant branches x 2 with poor attachments, 1 has very acute union and is laying over/crossing branches below, 1 branch with decayed wound on underside,
