Final Study Report

Latrobe River Flood Study

Prepared for
West Gippsland CMA

March 2015

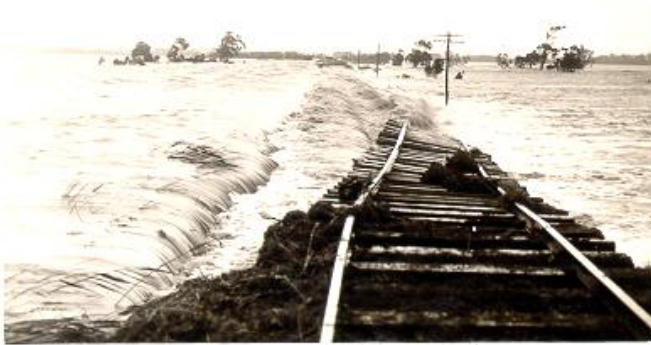
Plate 1 Water overtopping the Traralgon-Maffra railway embankment in 1934 (looking North)
